**Flood Control Project Maintenance
Levee Inspections****LMA District Cover Sheet****Spring 2016 Levee Inspection Results****Reclamation District No. 0307 Lisbon**

Spring 2016 Levee Inspection Results

Reclamation District No. 0307 Lisbon

| Waterway | | | Bank | Unit Miles |
|--|---|---|---|---|
| Unit No. 01 Sacramento River | | | Right | 6.56 |

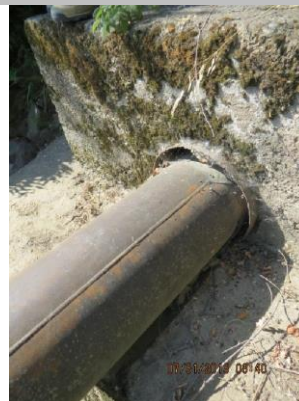
Photo 1 of 2 : UCIP_SP_2016_16743_28722.jpg

15-inch pipe sleeved through 21-inch pipe on WS slope at headwall.

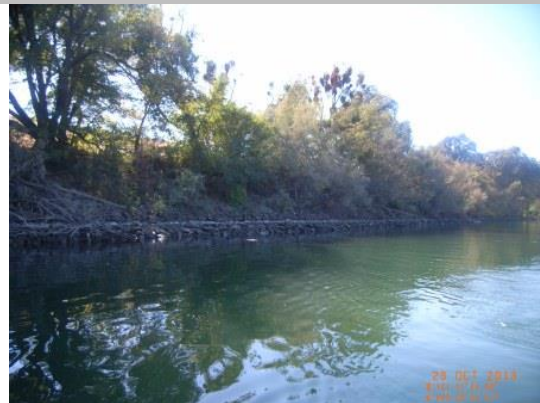
Photo 1 of 1 : SP_2016_RD0307_166_1_20160223_00001.jpg

| 2015: No observed changes. [2015 Site ID: SAC_48-6_R] | | | | | |

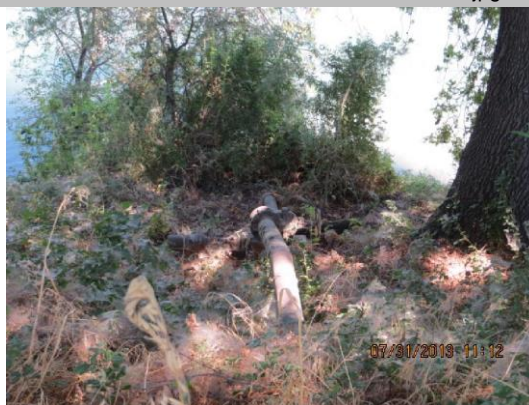
Photo 1 of 2 : UCIP_SP_2016_40794_28823.jpg

Pump and gate valve on WS slope.

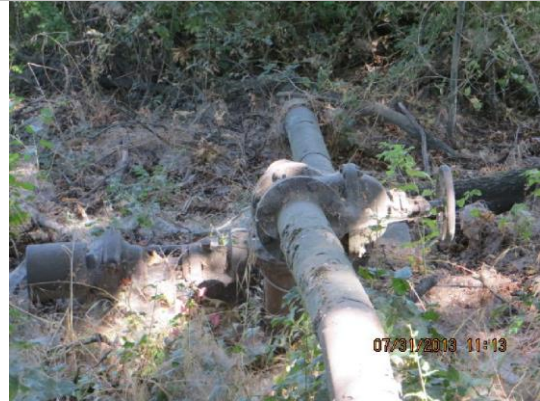
Photo 2 of 2 : UCIP_SP_2016_40794_28822.jpg

Pump and gate valve on WS slope.

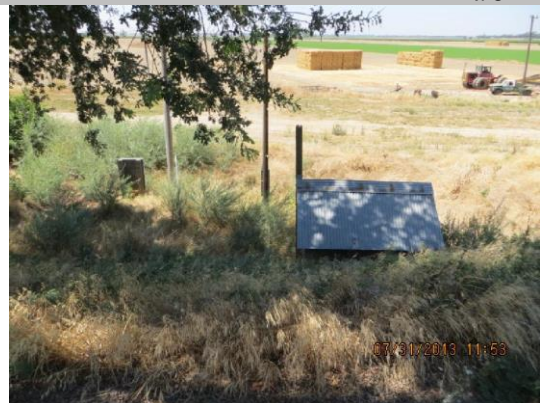
Photo 1 of 2 : UCIP_SP_2016_16815_28850.jpg

Pumphouse on LS toe.

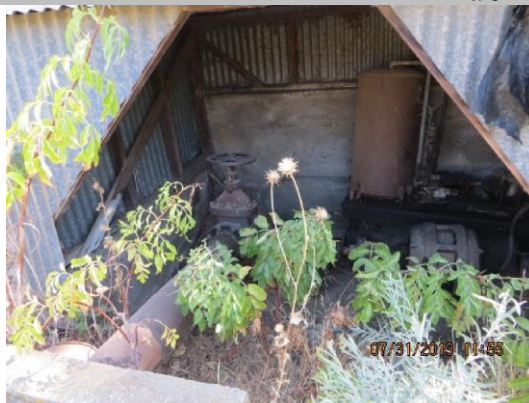
Photo 2 of 2 : UCIP_SP_2016_16815_28849.jpg

Pump and gatevalve inside pumphouse on LS toe.

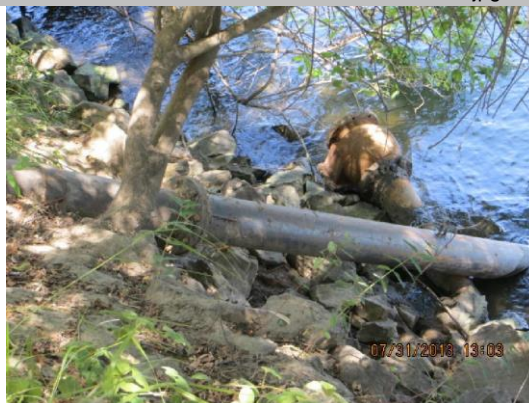
Photo 2 of 2 : UCIP_SP_2016_16843_28880.jpg

Pipe visible on WS toe.

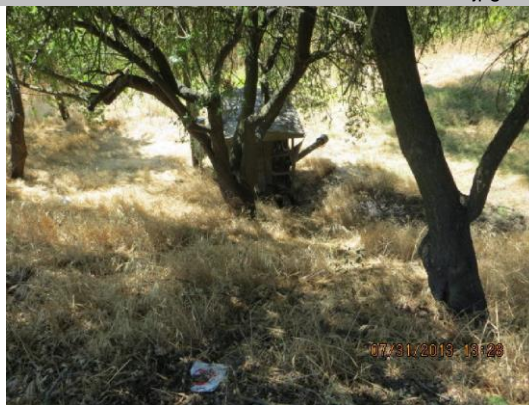
Photo 2 of 2 : UCIP_SP_2016_16923_28977.jpg

Pumphouse on LS toe.

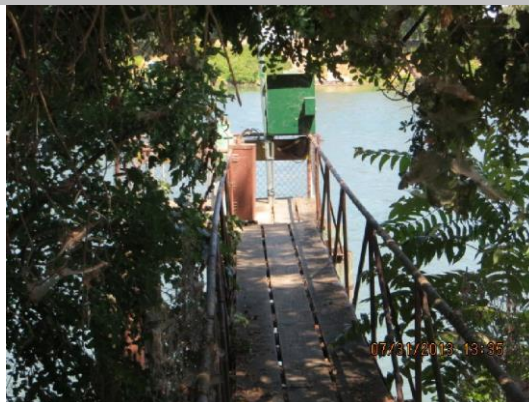
Photo 2 of 2 : UCIP_SP_2016_16924_28981.jpg

Pump and electrical controls on Pier at WS slope.

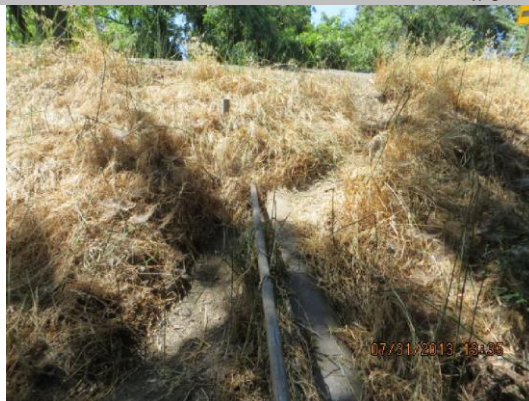
Photo 1 of 2 : UCIP_SP_2016_16925_28984.jpg

Conduit visible on WS slope.

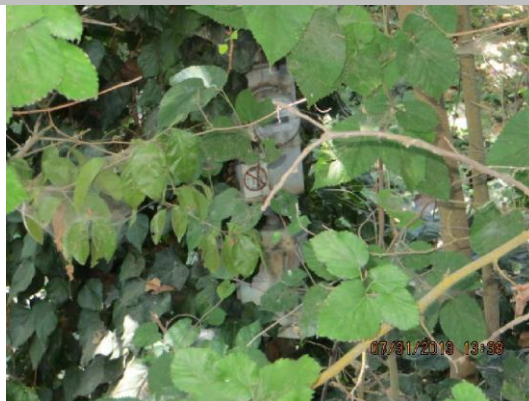
Photo 2 of 2 : UCIP_SP_2016_16925_28983.jpg

JP and meter on LS toe.

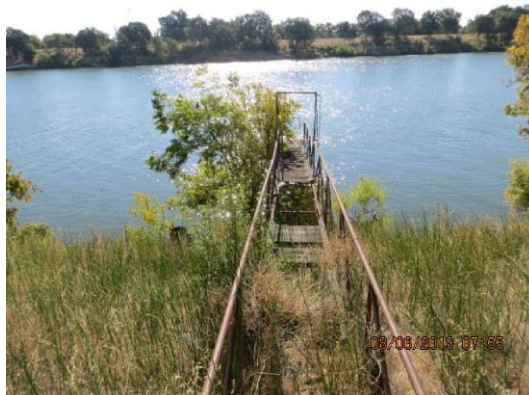
Photo 1 of 2 : UCIP_SP_2016_16983_29022.jpg

Metal walkway to pump on pier and gate valve actuator on WS slope.

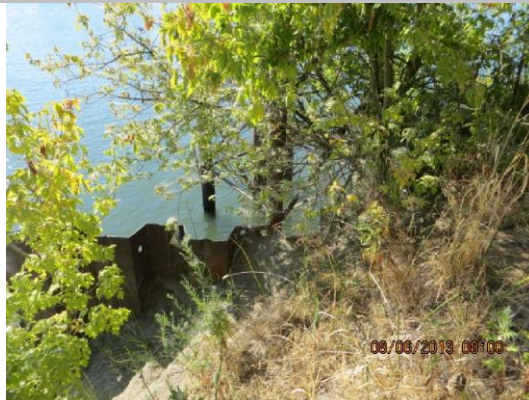
Photo 2 of 2 : UCIP_SP_2016_16983_29021.jpg

Sheet pile wall at WS toe.

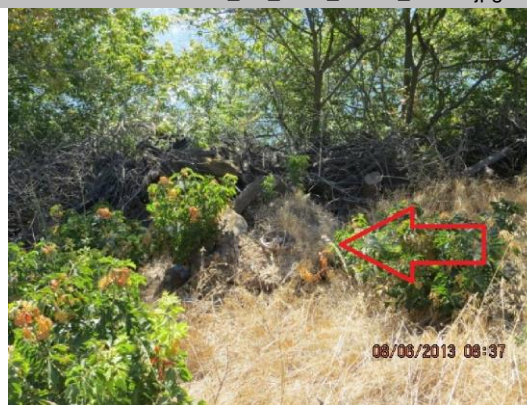
Photo 1 of 2 : UCIP_SP_2016_17128_29261.jpg

| FS_ID:17128 DS_ID:21684 EP_NO: 8038 Repair Type: Urgent Crossing Status: Found UCIP Comments: Wooden lid on 5-foot Diam. CMP riser rotten and could collapse. This could create a hazard for the public and should be replaced. Pipe appears abandoned and should be done so properly. FIELD_STRUCT_DESC: 6-inch steel irrigation pipe through the levee 13.5 feet below the crown. Gate valve in 5-foot diameter corrugated metal pipe riser on the waterward slope. Power pole and meter at LS toe (Permit No. 8038, 1972). Included in the 1959 O&M manual. FS Date: 7/31/2013 | | | | | |

Wooden lid at gate valve in CMP riser on WS slope.

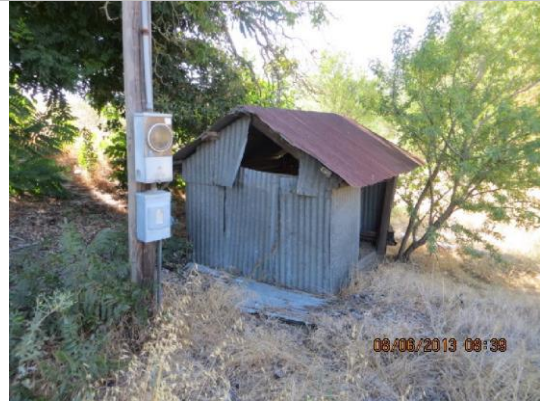
Photo 2 of 2 : UCIP_SP_2016_17128_29260.jpg

| FS_ID:17128 DS_ID:21684 EP_NO: 8038 Repair Type: Urgent Crossing Status: Found UCIP Comments: Wooden lid on 5-foot Diam. CMP riser rotten and could collapse. This could create a hazard for the public and should be replaced. Pipe appears abandoned and should be done so properly. FIELD_STRUCT_DESC: 6-inch steel irrigation pipe through the levee 13.5 feet below the crown. Gate valve in 5-foot diameter corrugated metal pipe riser on the waterward slope. Power pole and meter at LS toe (Permit No. 8038, 1972). Included in the 1959 O&M manual. FS Date: 7/31/2013 | | | | | |

Power Pole, meter, and pumphouse on LS toe.

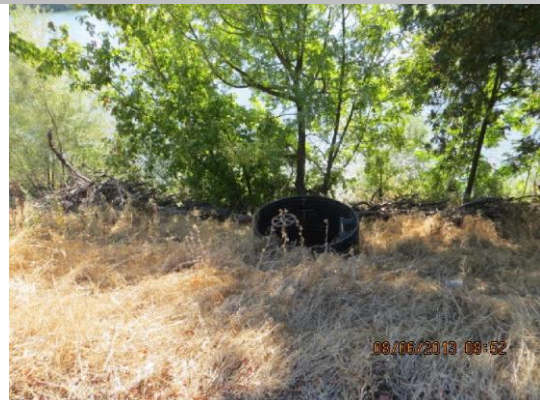
Photo 1 of 2 : UCIP_SP_2016_22670_38290.jpg

Slide gate in riser on WS slope.

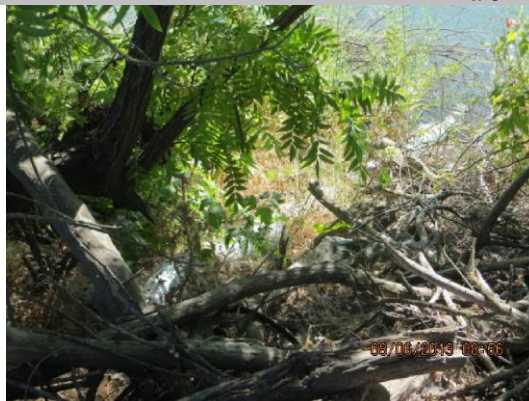
Photo 2 of 2 : UCIP_SP_2016_22670_38289.jpg

Pipe visible on WS slope.

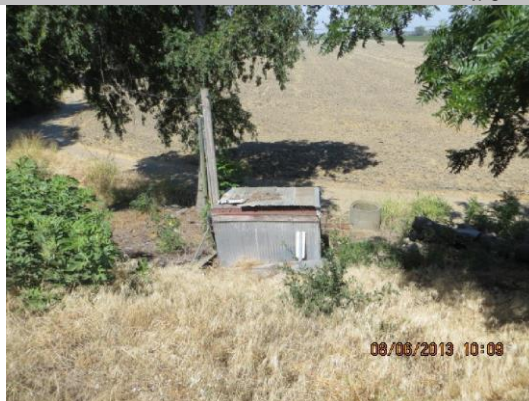
Photo 1 of 2 : UCIP_SP_2016_17183_29321.jpg

Pumphouse for 6-inch pipe at LS toe.

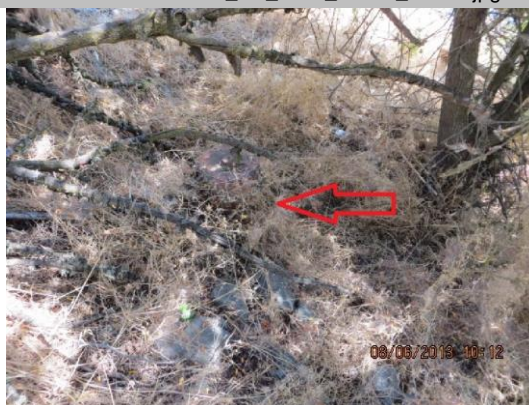
Photo 2 of 2 : UCIP_SP_2016_17183_29320.jpg

Gate valve on WS slope.

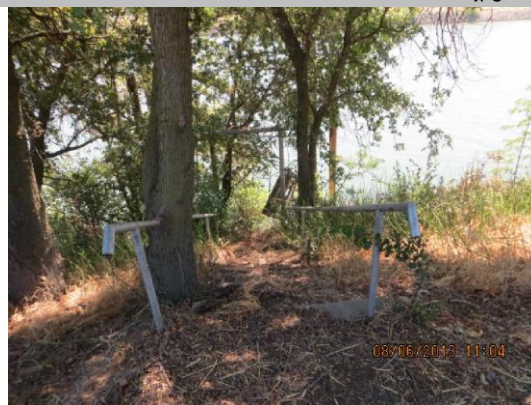
Photo 1 of 2 : UCIP_SP_2016_17184_29326.jpg

Pipe and gate valve on WS slope just downstream from stairs.

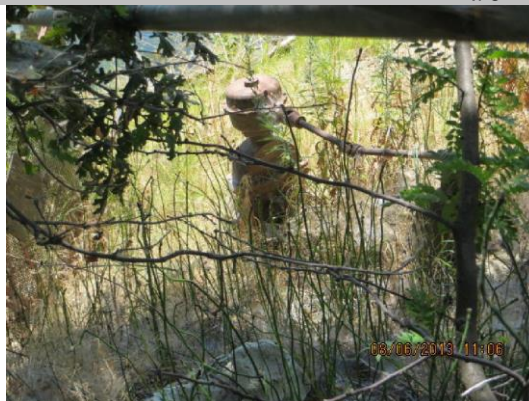
Photo 2 of 2 : UCIP_SP_2016_17184_29325.jpg

Gate valve on WS slope.

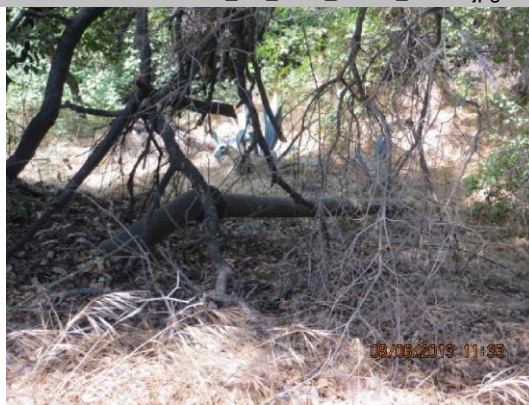
Photo 1 of 1 : UCIP_SP_2016_22671_38293.jpg

| FS_ID:22671 DS_ID:21693 EP_NO: N/A Repair Type: Non-Urgent Crossing Status: Found UCIP Comments: Pipe abandoned and should be done so properly. FIELD_STRUCT_DESC: 1 of 2: 6-inch steel irrigation pipe through the levee 1.5 feet below the crown Originally included in the 1959 O&M manual. FS Date: 8/6/2013 | | | | | |

Pipe visible on LS slope.

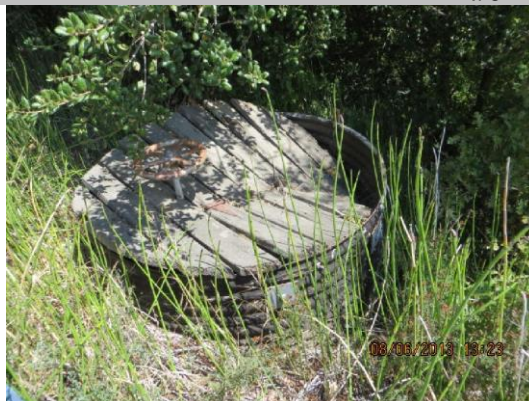
Photo 1 of 2 : UCIP_SP_2016_22710_38415.jpg

Gate valve in 5-foot diameter CMP riser on WS slope.

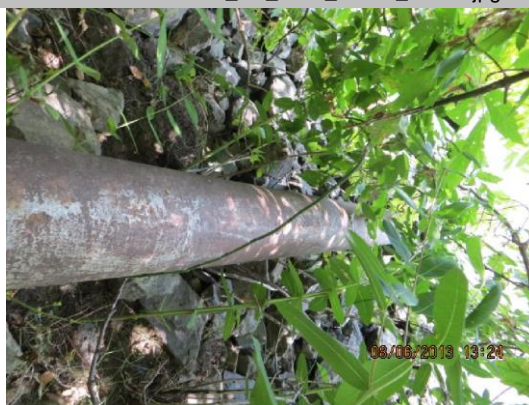
Photo 2 of 2 : UCIP_SP_2016_22710_38414.jpg

Pipe visible on WS slope.

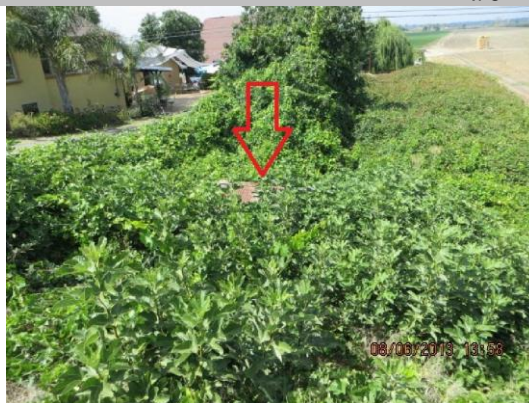
Photo 1 of 2 : UCIP_SP_2016_40546_29421.jpg

Pumphouse on LS toe.

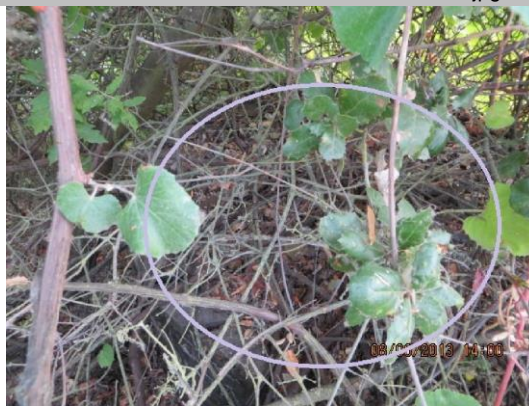
Photo 2 of 2 : UCIP_SP_2016_40546_29420.jpg

Gate valve in 5-foot diameter CMP riser on WS slope.

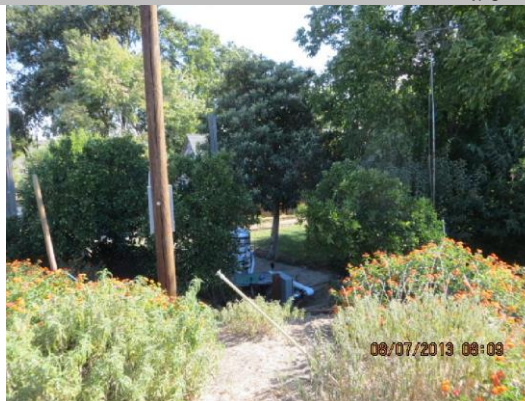
Photo 1 of 2 : UCIP_SP_2016_17287_29423.jpg

Pump and appurtenances on LS toe.

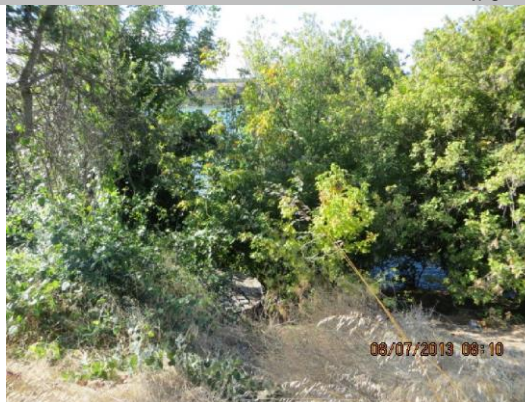
Photo 2 of 2 : UCIP_SP_2016_17287_29422.jpg

Gate valve in 5-foot diameter CMP riser on WS slope.

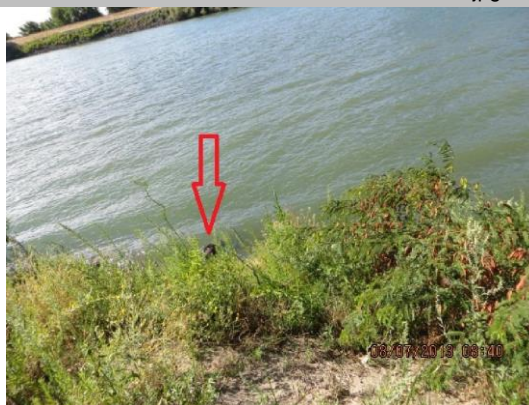
Photo 1 of 2 : UCIP_SP_2016_17343_29442.jpg

| FS_ID:17343 DS_ID:21702 EP_NO: 8051 Repair Type: Non-Urgent Crossing Status: Found UCIP Comments: Annular space between pipes does not appear to be grouted. FIELD_STRUCT_DESC: 10-inch steel irrigation pipe through the levee 16.8 feet below the crown. Pump, vent, Power pole, and gate valve on the LS toe. 36-inch concrete standpipe next to pump on LS toe (Permit No. 8051, 1972). 8-inch steel pipe sleeved through 10-inch. Originally included in the 1959 O&M manual. FS Date: 8/7/2013 | | | | | |

Pipe visible on WS toe.

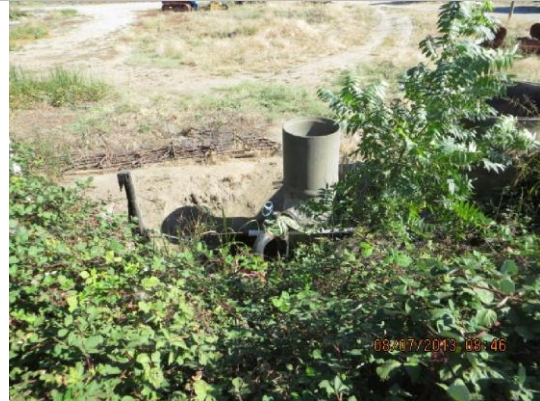
Photo 2 of 2 : UCIP_SP_2016_17343_29441.jpg

Pump, butterfly valve, vent, and concrete standpipe on LS toe.

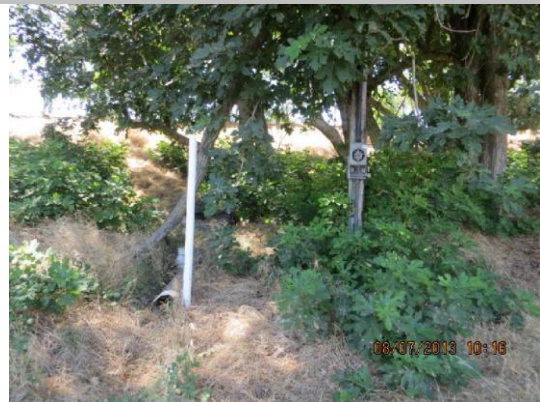
Photo 1 of 2 : UCIP_SP_2016_22711_38419.jpg

Power pole and meter off LS toe.

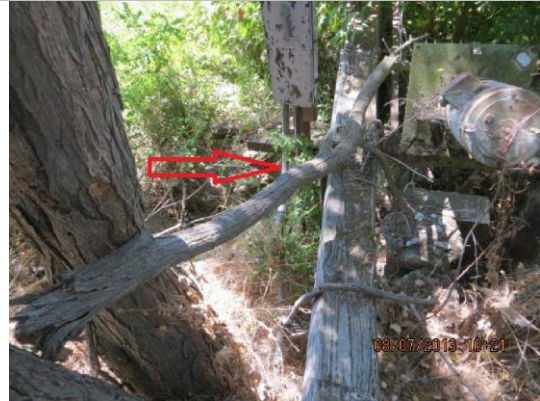
Photo 2 of 2 : UCIP_SP_2016_22711_38418.jpg

| FS_ID:22711 DS_ID:21713 EP_NO: 6519 Repair Type: Non-Urgent Crossing Status: Found UCIP Comments: Appears abandoned and should be done so properly. FIELD_STRUCT_DESC: 1.5-inch electrical conduit through the levee 1.0-foot below the crown. Slant pump and electrical panel on WS slope and a power pole and meter on the LS toe (Permit No. 6519, 1970). FS Date: 8/7/2013 10:24:00 AM | | | | | |

Electrical conduit visible at panel next to slant pump on WS slope.

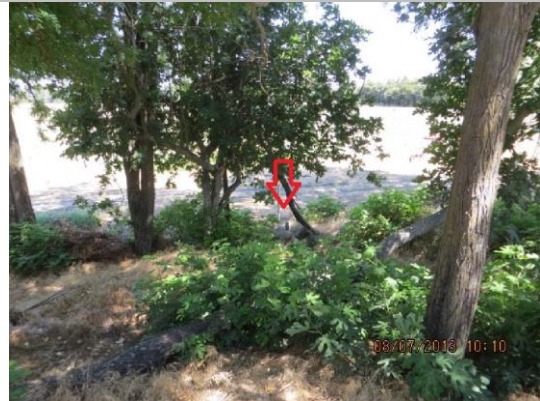
Photo 1 of 2 : UCIP_SP_2016_22712_38422.jpg

| FS_ID:22712 DS_ID:21732 EP_NO: 8053 Repair Type: Non-Urgent Crossing Status: Found UCIP Comments: Annular space between pipes does not appear to be grouted. FIELD_STRUCT_DESC: 20-inch steel irrigation pipe through the levee 14.7 feet below the crown. 16-inch pipe sleeved through 20-inch. Slant pump and gate valve on the waterward slope. Gate valve, power pole, and electric panel on LS toe (Permit No. 8053, 1972). Originally included in the 1959 O&M manual. FS Date: 8/7/2013 | | | | | |

Pipe on LS toe.

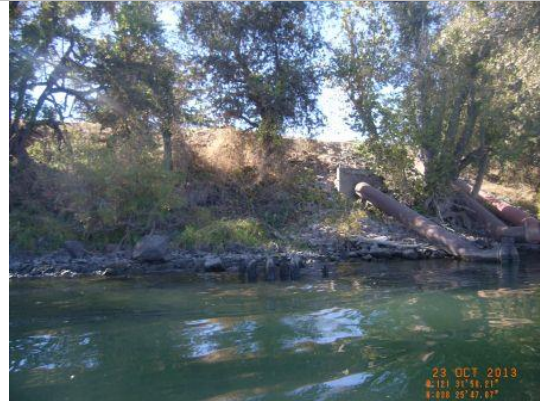
Photo 1 of 1 : SP_2016_RD0307_166_8_20160223_00003.jpg

| 2011 - Erosion pockets likely from tree popouts. This site has been in the inventory before and been fixed with emergency bank rock but continues to fail. 2015: No observed changes. [2015 Site ID: SAC_43-1_R] | | | | | |

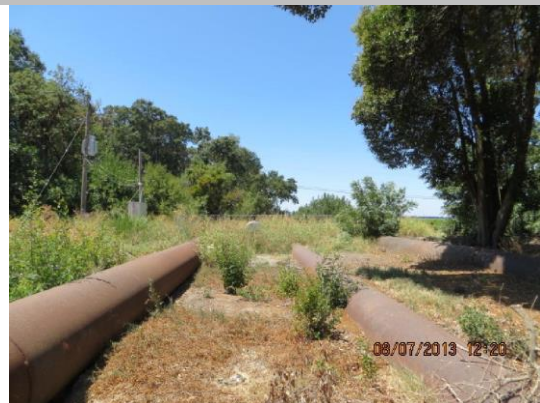
Photo 1 of 2 : UCIP_SP_2016_17404_29504.jpg

| FS_ID:17404 DS_ID:21707 EP_NO: 4096 Repair Type: Non-Urgent Crossing Status: Found UCIP Comments: Gate valve inaccessible to do fallen tree debris on steel platform. FIELD_STRUCT_DESC: 36-inch steel drain pipe through the levee 6-feet below the crown. Gate valve located just off LS toe on Steel platform. Pumping plant and trash rack located 200-feet off LS toe. Flap gate on the waterward end (Permit No. 4096, 1962). Replaced 36-inch pipe that was grouted in place at same location. FS Date: 8/7/2013 | | | | | |

Pipe visible on LS toe to pumping plant 200-feet off LS toe.
